ON THE JOB

MR and Internal Derangement

Dan L. Hobbs, M.S.R.S., R.T.(R)(CT)(MR), is an associate professor in the department of radiographic science at Idaho State University in Pocatello.

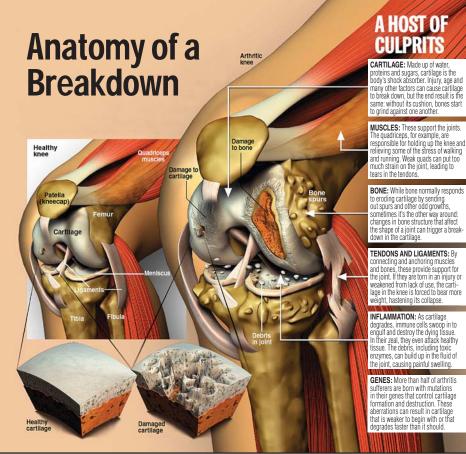
Fig. 1. Anatomy of a breakdown. This diagram shows the anatomical components of the knee, the mechanisms that cause injury and several processes that may result in pain to the joint itself. (Diagram by Joe Lertola. Reprinted with permission from: Time magazine, December 9, 2002 issue, posted December 1, 2002.)

ments become weakened or torn, the cartilage of the knee is forced to bear more weight, resulting in injury or even collapse of the joint. Regardless of the mechanism of injury, osteoarthritis often is a common result; what's more, recent studies⁶ have shown that osteoarthritis is influenced not only by mechanical processes, but that biochemical and genetic factors also play a role. Thus, "...researchers have discovered an array of biochemical messages that are traded between bones, muscles and other parts of the body and play a key role in keeping joints healthy."⁵ Consequently, there are myriad reasons, ranging from injury to genetic predisposition, that cause knee-related problems. (See Fig. 1.)

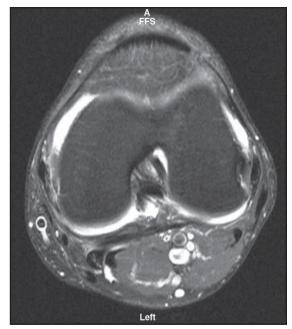
Fig. 2. Axial localizer. This image was used to prescribe the sagittal and coronal images. (Image courtesy of Owen Bartschi, R.T.(R)(MR), Idaho Medical Imaging, Pocatello, Idaho.)

A 56-year-old male patient was evaluated for chronic left knee pain that he had experienced for the past 2 years. After appropriate screening, he was placed in a 1.5-T magnet scanner (Espree, Siemens AG, Munich, Germany). After placement of the knee coil, the patient was positioned in the bore of the magnet; an axial localizer was then performed. (See Fig. 2) This was followed by a complete multiplanar MR series, which consisted of sagittal and coronal T1-weighted, proton density-weighted and fat saturation sequences.

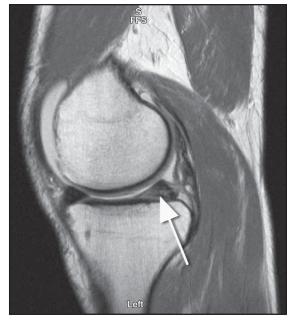
Fig. 4. Medial menicus. Arrow denotes a moderate-sized horizontal tear of the medial meniscus. (Image courtesy of Owen Bartschi, R.T.(R)(MR), Idaho Medical Imaging, Pocatello, Idaho.)

When evaluating the sagittal images, the anterior and posterior horns of the menisci appear as triangular densities in the center of the knee in both the lateral and medial compartments. The menisci are somewhat broadened on each end and taper to a pointed triangular shape toward the center of the image. The lateral meniscus in the sagittal sequence is intact and normal in appearance and shape. (See Fig. 3) On the other hand, the medial meniscus demonstrates irregularities in the posterior aspect of the body. (See Fig. 4.) This defect can be best seen on images that have narrow meniscal windows. (See Fig. 5.)

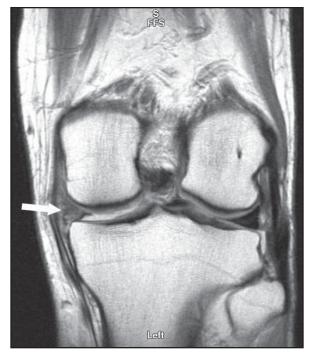
Fig. 6. Coronal image. Arrow denotes irregular densities in the medical meniscus. (Image courtesy of Owen Bartschi, R.T.(R)(MR), Idaho Medical Imaging, Pocatello, Idaho.)

Lastly, in the case presented, a coronal image shows irregular densities in the medial menicus. (See Fig. 6.) Also, the radiologist reported irregularity and partial

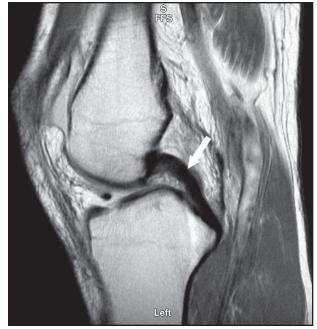
Fig. 7. Posterior cruciate ligament. Arrow denotes normal posterior cruciate ligament. (Image courtesy of Owen Bartschi, R.T.(R)(MR), Idaho Medical Imaging, Pocatello, Idaho.)

> loss of the articular cartilage covering the medial femoral condyle and posterior medial tibial plateau. It is interesting to note the normal appearance of the posterior cruciate ligament. (See Fig. 7.)
